Details	Information
Name of the Mine	Hutti Gold Mine
Owner of the Mine	M/s Hutti Gold Mines Company Limited
Date and time of accident	On 30.10.2019 at about 19:10 hrs
Number of Persons killed	Nil
Number of persons seriously injured	01 (One)
Photographs (maximum 02 numbers)	<div style="display: flex; justify-content: space-around;">

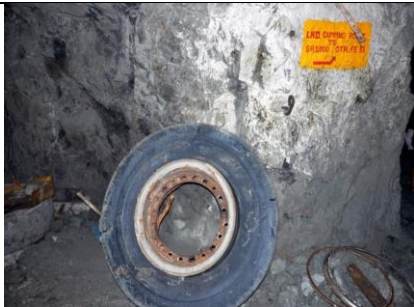
</div> <p data-bbox="571 1115 906 1267">Picture. 01: Damaged flange, lock ring and wheel of the LHD</p> <p data-bbox="991 1115 1362 1267">Picture 02: worn out locking rim and bead seat area of the rim.</p>
Prima facie cause of the accident	<p data-bbox="555 1290 1407 1850">While inserting the wheel and aligning the holes of a reconditioned rim of a wheel onto the newly installed studs, in the front left axle hub of an electrically operated LHD, by a crew consisting of one Foreman and four Workmen, in an underground metal mine, one of the Workmen tapped the reconditioned multi-piece wheel rim of the wheel, three times, in between the wheel studs, with a result the lock ring of the wheel popped off from the bead seat area of the rim, inflicting serious bodily injuries to the Workmen, who was positioned in front of the rim</p>
