ALERT

Name of the mine : Balram Opencast Mine
Owner of the Mine : M/s Mahanadi Coalfields Ltd. Date
and time of the accident : 28.05.2019, 02:30 Hrs
Number of persons Killed : 1(One)

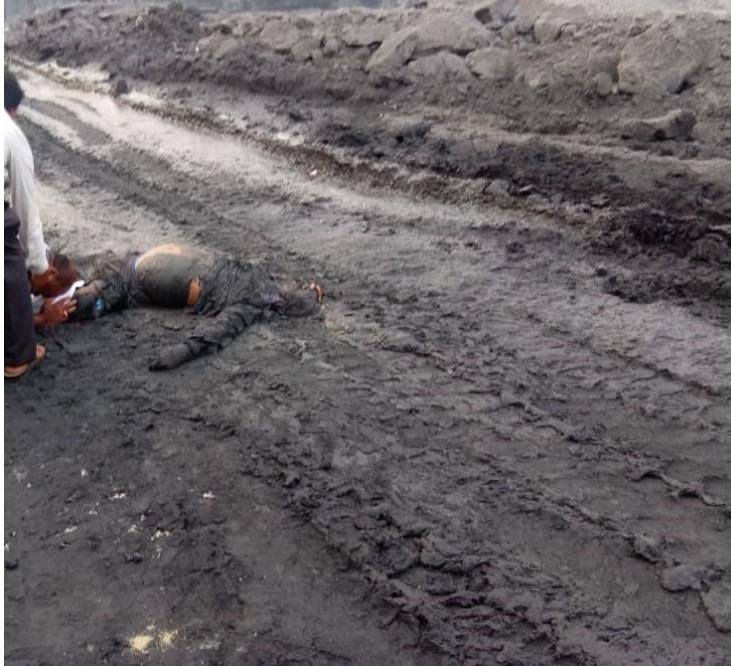
Prima facie cause of the accident:

While a worker was walking on the haul road from top OB bench to coal face, he was hit and run over by the loaded coal tipper plying on the same road, thereby inflicting serious bodily injuries to the person due to which he succumbed at the spot.

Mine management may be addressed to arrange a training programme for all the security guards working in the mine.

Safe operating procedures of specialized equipment for specialized jobs and maintenance shall be reviewed frequently.

Safety Management Plan shall be reviewed from time to time keeping in a view of such occurrences on the haul roads.

The code of practice for design, construction, maintenance and layout of haul roads shall be prepared and circulated to all the persons concerned and displayed at conspicuous places in the local language.

The code of practice for operations of patrolling and protecting, safeguarding and securing all the places/premises & assets within the mine was not designed and distributed to security guards and persons connected to those operations and displayed at conspicuous places in the local language.

All the persons employed in the mine shall wear fluorescent jackets at all times

The transport rules, signals, road signs, fluorescent signage and safety slogans shall be provided along the haul road.

The conditions of haul roads specified in Gazette Notification G.S.R/976 (E) dated 1st October, 2018 shall be strictly followed.
