SAFETY ALERT: 35 /2025

**SUBJECT: Occurrence of Fatal Accident caused by falling of tubing from mobile crane engaged in drilling Rig E-1400-14 deployed in Well No#ADEL.**

1.	Name of the mine	:	Tripura Drilling Mine
2.	Name of Owner	:	M/s. Oil and Natural Gas Corporation Limited.
	District	:	West Tripura
	State	:	Tripura
3.	Mineral	:	Oil & Gas

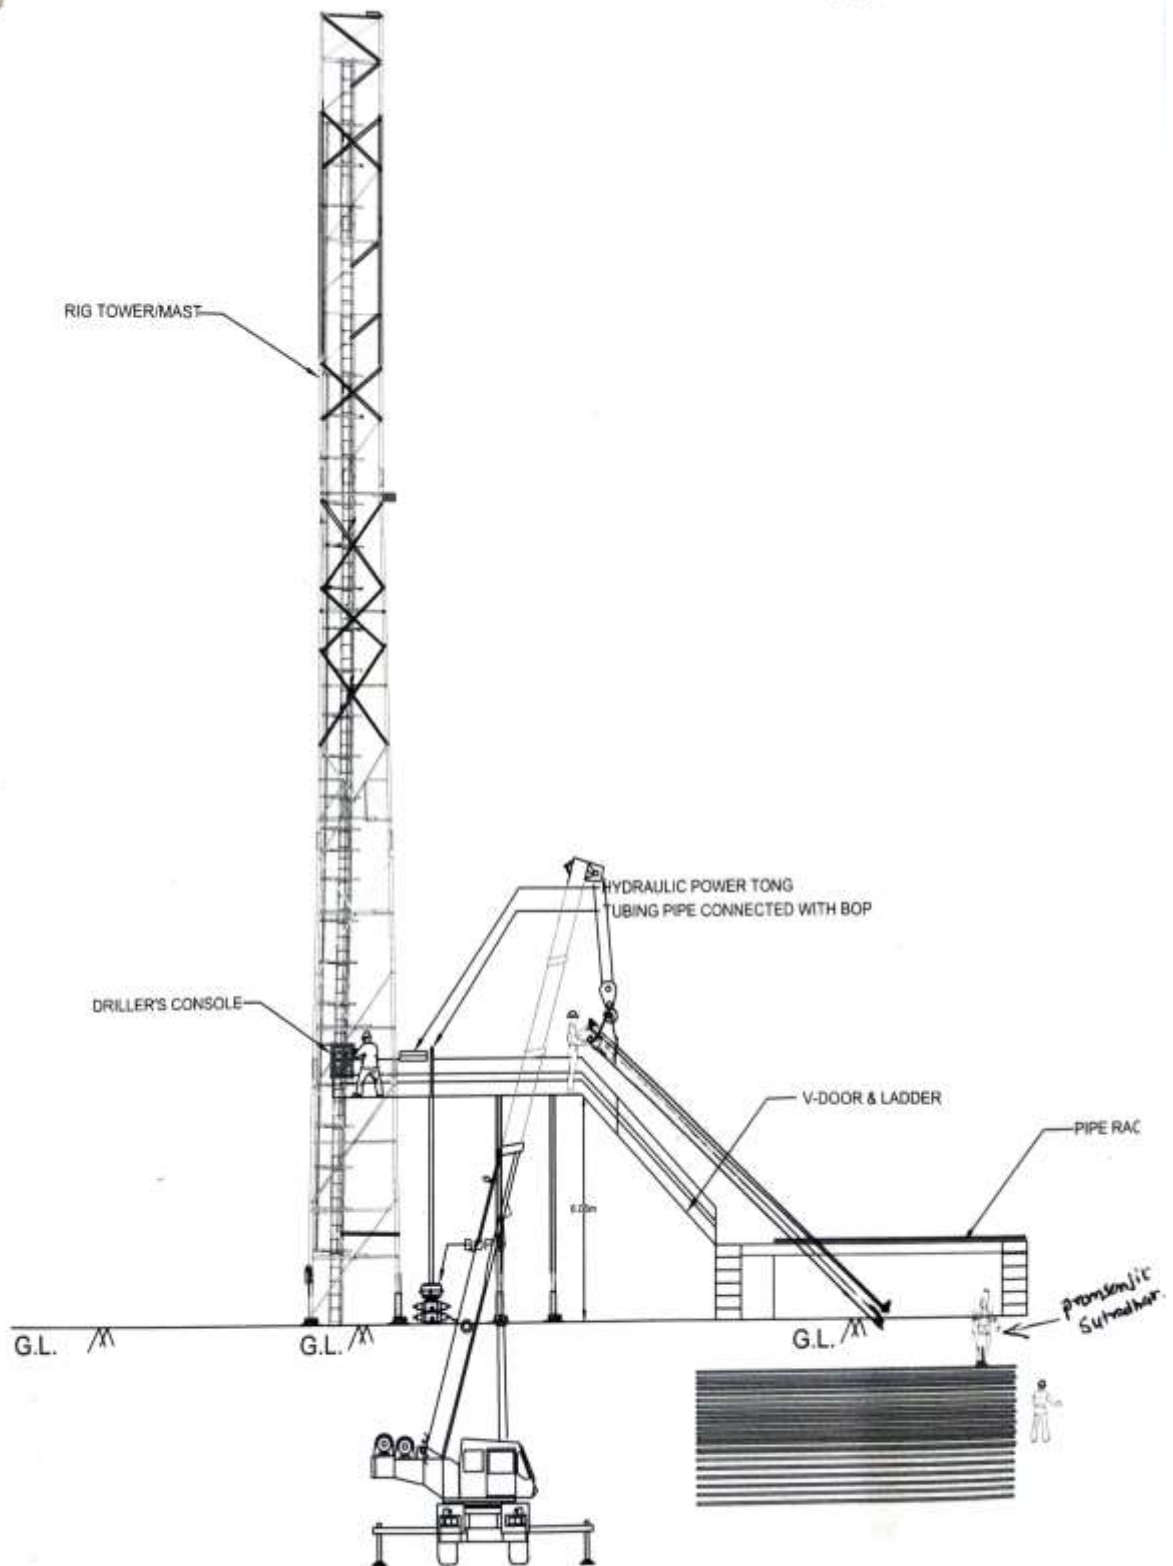
# ANNEXURE - 1

7.	Seriously Injured	:	None.
8.	Brief Cause	:	
	"While Running-in operation were carried out at drilling rig during stacking (laying down) of 5" Drill pipe with the help of 40Ton truck mounted crane, suddenly sling detached from hook of the crane and drill pipe fell on the Slinger and inflicted serious bodily injury on his head to which he succumbed while being treated at the hospital".

9.	Sketches showing the accident	:	Attached as Annexure-1
10.	<b>Best Practices:</b> <b>(a) Crane Hook Safety</b> <ul style="list-style-type: none"> <li>Use hooks fitted with <b>positive locking safety latches</b> that cannot open under load.</li> <li>Ensure NO lifting is done with: Hooks without locking latch, Damaged, bent, or worn-out hook points</li> <li>Ensure <b>correct hook throat opening</b> and avoid side-loading of hook.</li> </ul> <b>b) Sling Selection &amp; Condition</b> <ul style="list-style-type: none"> <li>Only use <b>certified slings</b> (wire rope/webbing/chain) with: Valid test certificate, Clearly marked SWL/WLL</li> <li>Inspect slings daily for: Broken wires, Cuts or abrasion, Deformation, Damaged eyes/splices, Corrosion</li> <li>Remove from service immediately if defects are found.</li> </ul> <b>c) Proper Sling–Hook Compatibility</b> <ul style="list-style-type: none"> <li>Ensure: Sling eye fits properly into hook saddle, Safety latch fully closes, Sling is not allowed to ride on latch tip, No twisting/kinking of sling legs</li> </ul>
