## ACCIDENT ALERT

<b>Details</b>	
Name of Mine	Kusmunda OC Mine
Owner of the Mine	M/s SECL
Date and time of accident	<b>23.07.2020 (1<sup>st</sup> Shift) (Time: 07.00 hrs)</b>
Number of Persons Killed	01
Number of persons seriously injured	00
Photographs (maximums two numbers)

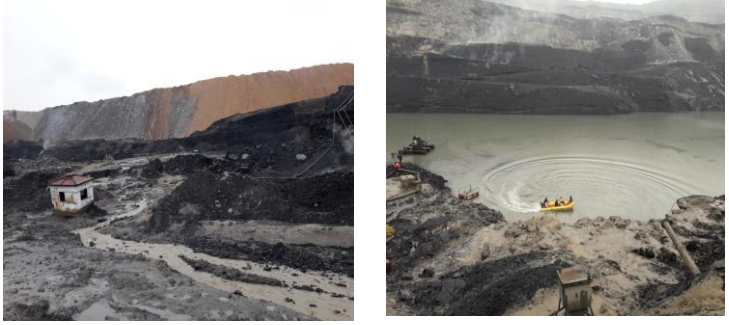
Prima facie cause of accident	<p><b>0993– Drowning in water</b></p> <p>“While during a heavy rain two contractual workmen on the way to their workplace in an opencast coal mine, were taking shelter in a rest shelter located near the bank of a sump, suddenly on seeing a localized flash flood of rain water with mud coming from the rise side workings, they attempted to escape from the shelter, in which one of them slipped and was carried along with the flowing muddy water and fell into the sump filled with water up to a depth of about 8 m, who was later recovered dead after about 34 hours, whereas the other workmen escaped unhurt”.</p>
